Wrong Way Wednesday | Jan. 20, 2016

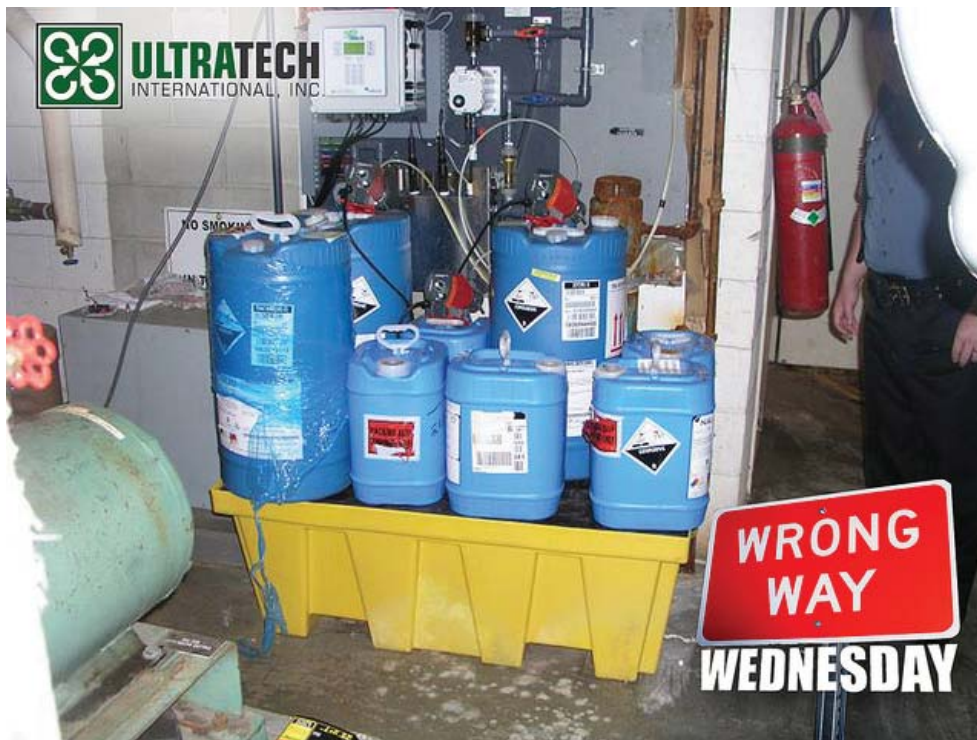
The obvious problem with today's "wrong way" scenario? THESE GUYS ARE USING SOMEONE ELSE'S SPILL PALLET!! That pallet is likely to cause blindness, seizures and spontaneous combustion. But the competition's shortcomings aside the other thing that jumps out is the ridiculous amount of containers crammed onto the top.

#3 is usually the focal point of this reg. But actually, our WWW perpetrator's would meet that part of the regulation. There are (3) what appear to be 30-gallon containers and (5) 5-gallon containers, for a total of 115 gallons. The regulation requires 10% of the total volume (in this case 11.5 gallons) OR the single largest container, which in this case would be 30 gallons. So as messy and voluminous as this set up looks, the federal regulations only require 30 gallons. The capacity of this pallet is 66-gallons. Even if I guessed wrong on the larger drums and those were 55-gallons, the total would be 190 gallons, and the single largest container would be 55-gallons which would be the required sump capacity for the pallet.

The real issue here (potentially, depending on the inspector) is the first part of #1 in the summary, "The containment unit must underlie the containers..." It is pretty clear that the pallet does not underlie several of the containers and, depending on the location of a leak, would not be able to properly contain the spill.

The obvious one would be to get a bigger pallet. More specifically, an ULTRA-Spill Pallet. But, if there is no additional floorspace available, the Ultra-Stacking Shelf could be used to provide additional space on top of the pallet.
